# **An Approach To Find The Cause For The Foam Formation In Bellanduru Lake Southeast Region, Bengaluru**

**Abstract:** Foam is produced due to various sources and activities. Huge amount of foam accumulation causes many problems such as traffic nuisances, obstruction to vision, odour problems etc., This paper has assessed the quality of Bellanduru Lake to discover the cause for foam formation. Parameters like COD, BOD, Microbiological analyses are carried out. Only 1% of foam will be caused by detergents; rest 99% forms due to action of water with air. Foam increases due to turbulence and foam enhancing agents. Some microorganisms like filamentous bacteria, are also said to cause foam formation. This paper assesses about the reason for foam generation in Bellanduru Lake-Southeast part.

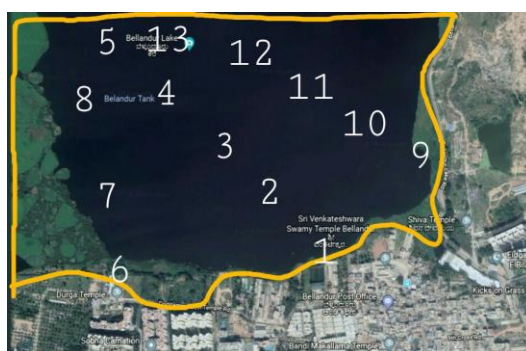
Fig. 3: Samples Collection Stations in Bellanduru Lake Southeast Region, Bengaluru

For investigations, water samples were collected from thirteen different sites selected from Bellanduru Lake that covered Southeast part of lake during January 2018 to April 2018. Polyethylene bottles (2 Litre capacity) were filled with the lake water by grab sampling. The locations of sampling are shown in the Fig. 3. The samples were collected from 15 cm below water surface. The samples collected were delivered to the analytical laboratory for analyses directly. The analyses of water samples for

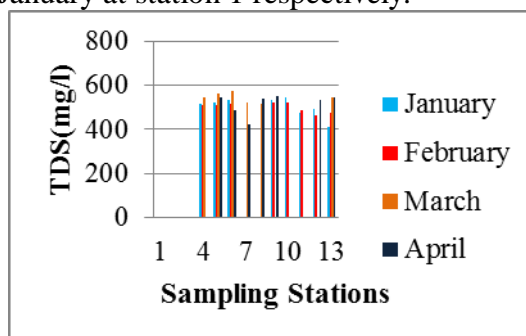
Fig. 4: Graphical Representation of TDS

TDS has its source from livestock wastes, septic system, landfills, nature of soil, dissolved minerals, iron and manganese. 500mg/l and 2000 mg/l are the desirable and permissible limits as per BIS. Excess TDS may lead to hardness, scale deposition, staining, corrosion of pipes and fittings. It was found that the maximum value of 575 mg/l and minimum value of 1 mg/l values in the water samples are found during March at station 6 and January at station 1 respectively.

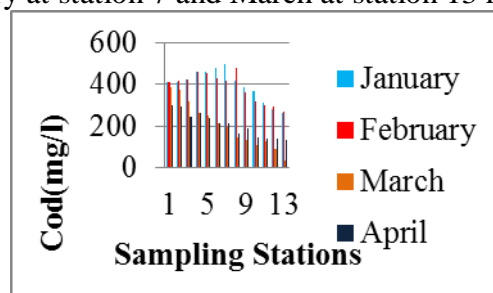
Fig. 6: Graphical Representation of COD

The sources are natural or more probably the added or organic matter. It denotes the overall quality of the water sample. The BIS value for COD is 250 mg/l. maximum and minimum values of COD are 498 mg/l and 32 mg/l during January at station 7 and March at station 13 respectively.

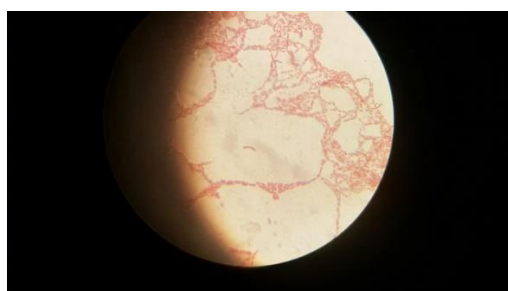
Fig. 8: Slide 2 of Microbiological Analysis

Cocci were found to be in chains and few gram positive cocci in cluster were also observed. They are found to be Gram positive cocci (Purple) when focused under 100X oil immersion. In the other slides, Gram negative rod shaped bacteria in chains were found.

Following are the images of slides of foam sample observed for micro-organisms detection.
